**Estudo de azulejos do século XIX e  
desenvolvimento de réplicas**

**Study of 19<sup>th</sup> century wall tiles for technical replicas  
development**

Tese apresentada à Universidade de Aveiro para cumprimento dos requisitos necessários à obtenção de grau de Doutor em Engenharia Civil, realizada sob a orientação científica da Doutora Ana Luísa Lomelino Velosa, Professora Auxiliar do Departamento de Engenharia Civil da Universidade de Aveiro e coorientação do Doutor Paulo Barreto Cachim, Professor Associado do Departamento de Engenharia Civil da Universidade de Aveiro e do Doutor João Paulo Coroado, Professor Coordenador do Instituto Politécnico de Tomar.

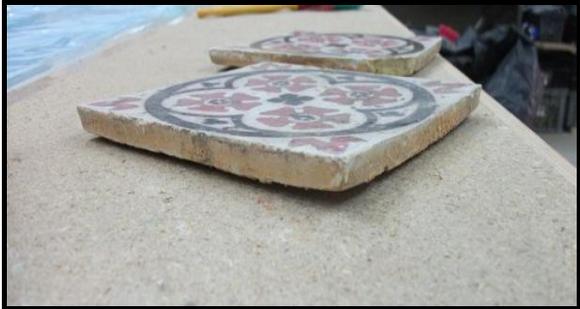
<b>Production defects</b>		
<p>Ceramic body bending</p>	<p>The ceramic body is not completely flat presenting bending due to production problems (pressing, drying or glaze tensioned)</p>

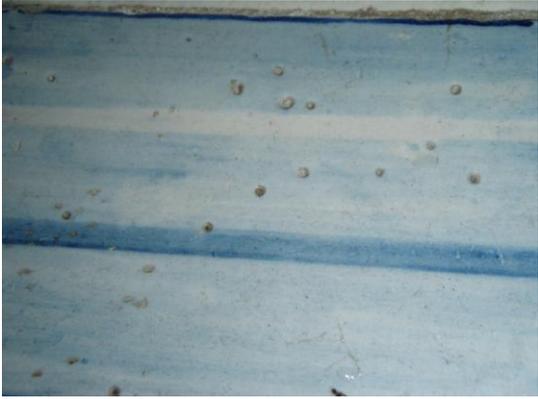
<p>Crater</p>	<p>Very big pin holes and less numerous</p>

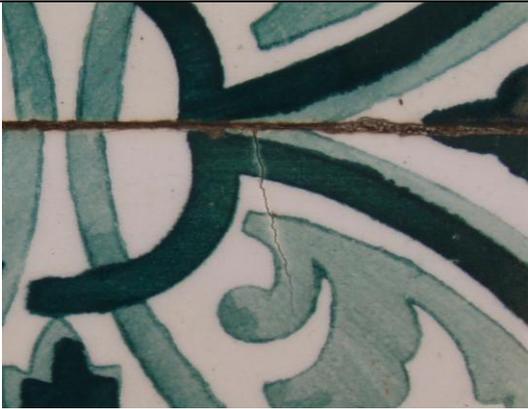
<p>Crack</p>	<p>Ceramic body separation. Pressing, drying or firing defect.</p>

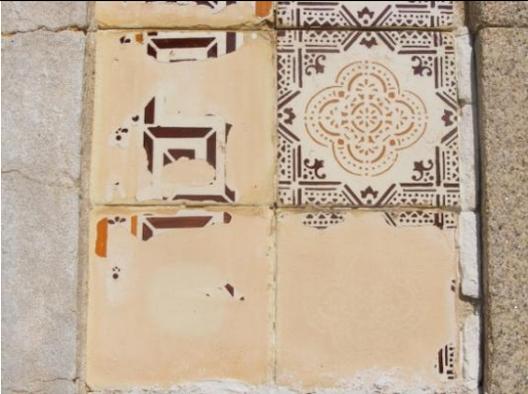
<p><b>Panel defects</b></p>		
<p>Glaze detachment</p>	<p>The glaze comes out leaving the ceramic body exposed</p>

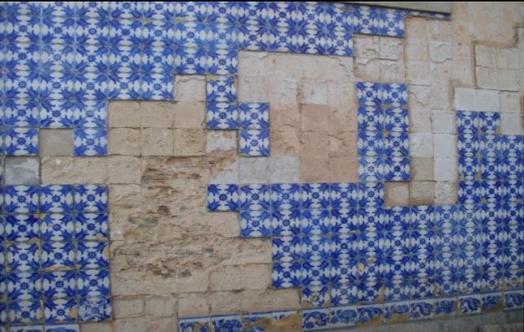
<p>Tile lacunae</p>	<p>Tiles fell down after tile detachment</p>

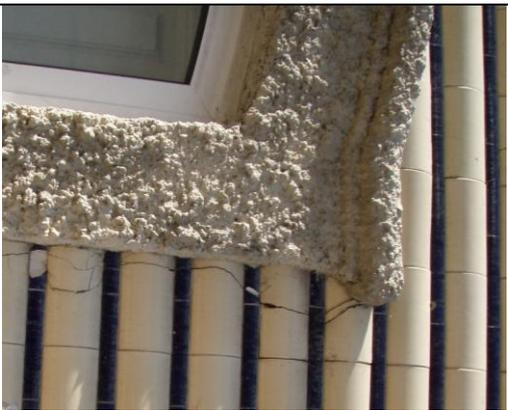
<p>Structural crack</p>	<p>Cracks on the tiles provoked by the building structural movements</p>

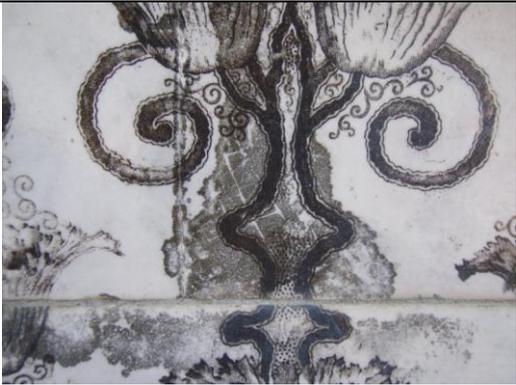
<p>Staining</p>	<p>Stains promoted by the presence of micro-organisms that lie under the transparent glaze</p>

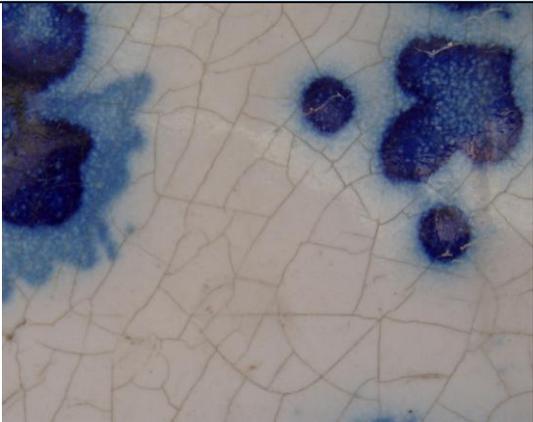
<p>Mix Factors</p>		
<p>Glaze crazing</p>	<p>The glaze cracks due to stresses between the glaze and the ceramic body. This can be due to a bad thermal expansion coefficient agreement between them or by moisture expansion of the ceramic body.</p>

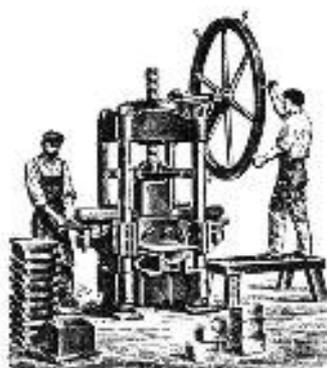
Figure 10 - Example of a manual tile press (Prostes 1907)

Another English accomplishment was made in Herbert Minton's factory in Stoke-on-Trent (England) that in 1835 first to use the mechanical pressing of tiles, bringing tile production to a new era: the serial production (Ferreira 2009). These presses were manual, as in Figure 10.

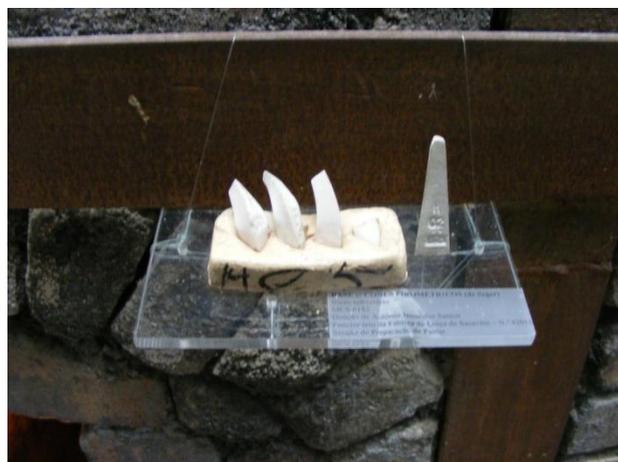
Figure 21 – The remaining of a cone firing control (author' photo)

Since ancient times the maximum firing temperature control was made visually, being the master consulted to verify the colour of refractory material or colour inside the kiln, using the "colour and brilliance pyrometer" experience of radiation of the materials under the heat of the flames. Later, in a technological giant step, pyrometric cones were invented by Josiah Wedgwood (England) in 1782. But it was Hermann Mow in 1886 that developed the cones bringing them up to the modern era. Its marketing must have begun around 1896. The cone consists of ceramic material the composition of which defines the softening temperature of each cone (each cone has a number associated with its softening temperature). The cones do not give a firing temperature, but the time integration with the temperature, the so-called equivalent temperature. Three to four cones with different softening temperature were placed together in a support (Figures 21 and 22) and placed in a kiln entrance for easy visualization. With the flexion of the right cone, the combustion material was suspended as firing reached the maximum temperature. The kiln temperature would be considered as being the one between the cone less flexed and the one that remained standing.

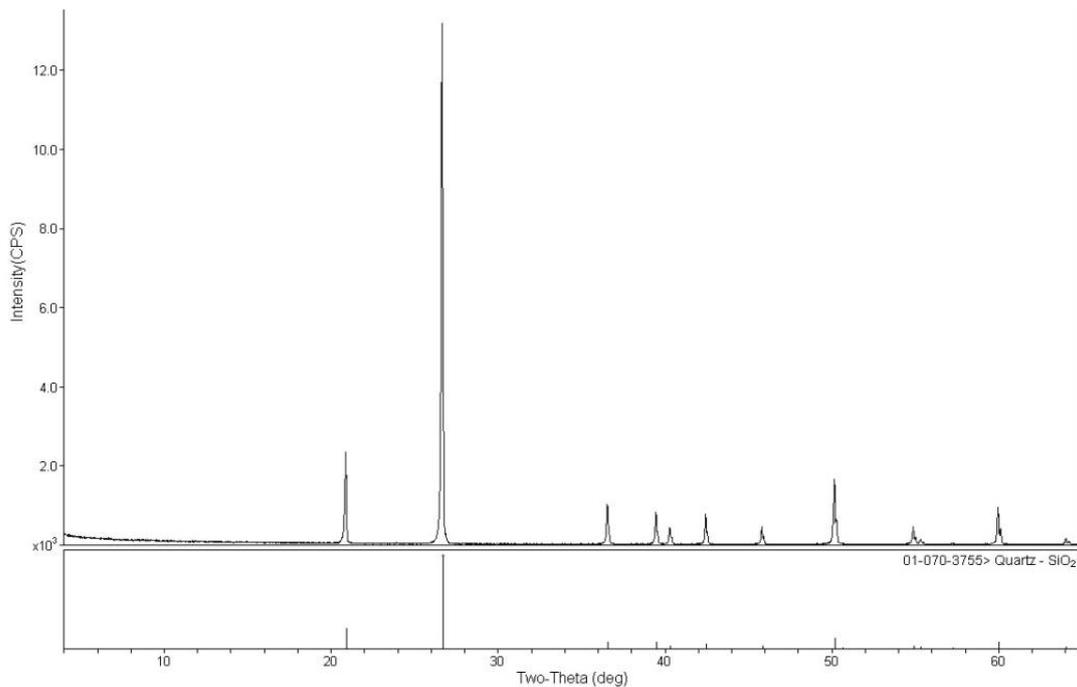
Figure 27 – Quartz sand XRD

The quartz sand, with reference RM 41K, from Sibelco- Rio Maior (n° 14 on Figure 27) was considered because it is a commercial sand exploitation specially used in the ceramic industry. Its XRD is as Figure 27 and XRF as Table 7.

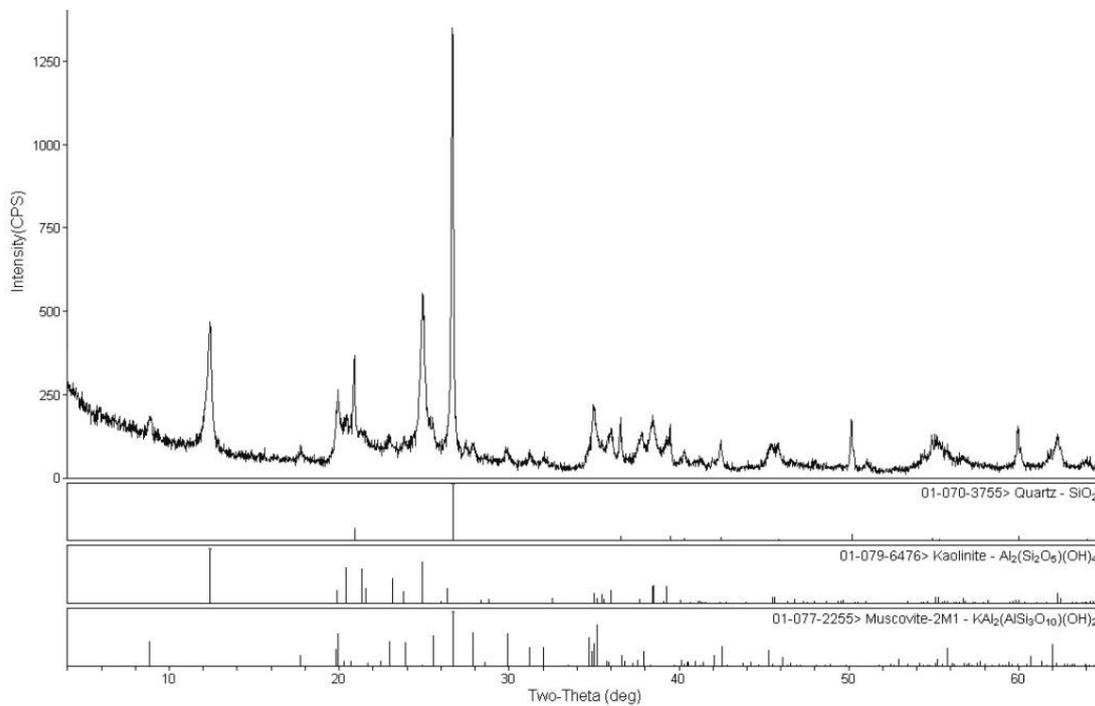
Figure 28 – Ball clay XRD

Ball clay was used with the reference BM-9 from Mário Moderno – Rio Maior, with XRD as Figure 28 and XRF as Table 8. It is a plastic clay giving to the ceramic body the ability to change its shape and maintain it without facing rupture.

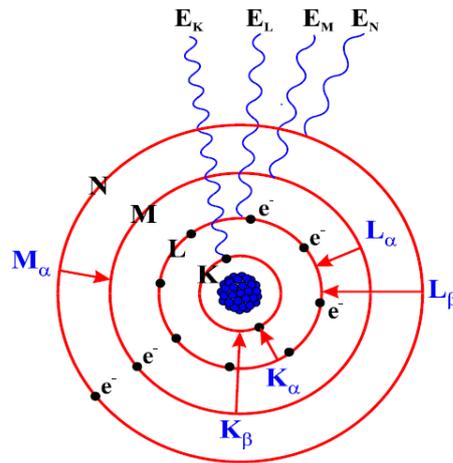
Figure 34 – Characteristic radiation (Rigaku)

transition will cause  $\alpha$  radiation (transition from L-shell towards K-shell will cause  $K\alpha$  radiation) a two level transition will cause  $\beta$  radiation and a three level transition  $\gamma$  radiation (Figure 34).

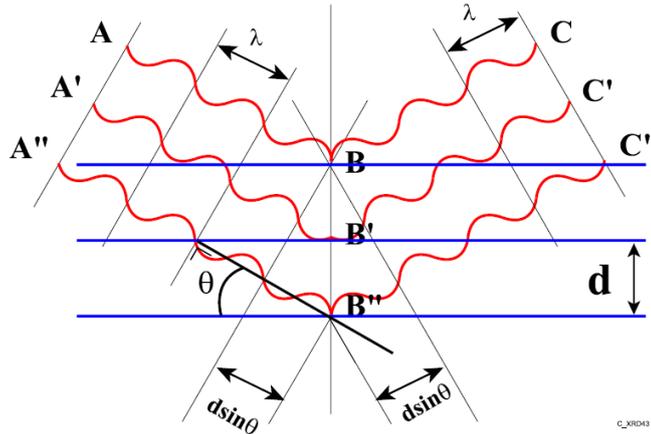
Figure 35 – Condition for diffraction of X-ray (Rigaku)

A crystal is a solid with a regular and periodic arrangement and a natural shape of a polyhedron (Rigaku , Gomes 1979). Usually a crystal lattice is drawn as a set of parallel lines at a distance  $d$  where all atoms are situated in these planes. When a monochromatic beam falls onto a crystal lattice, a diffracted beam will only result in certain directions. As diffraction conditions, it is necessary that the waves emitted by the individual atoms are in phase with each other in the direction of detection. Other diffraction condition is that the incident beam, the diffracted beam and the normal to the reflecting surface all lie in one plane and the angle of the incident beam is the same as the angle of the diffracted one (Figure 35) (Rigaku , Gomes 1979).

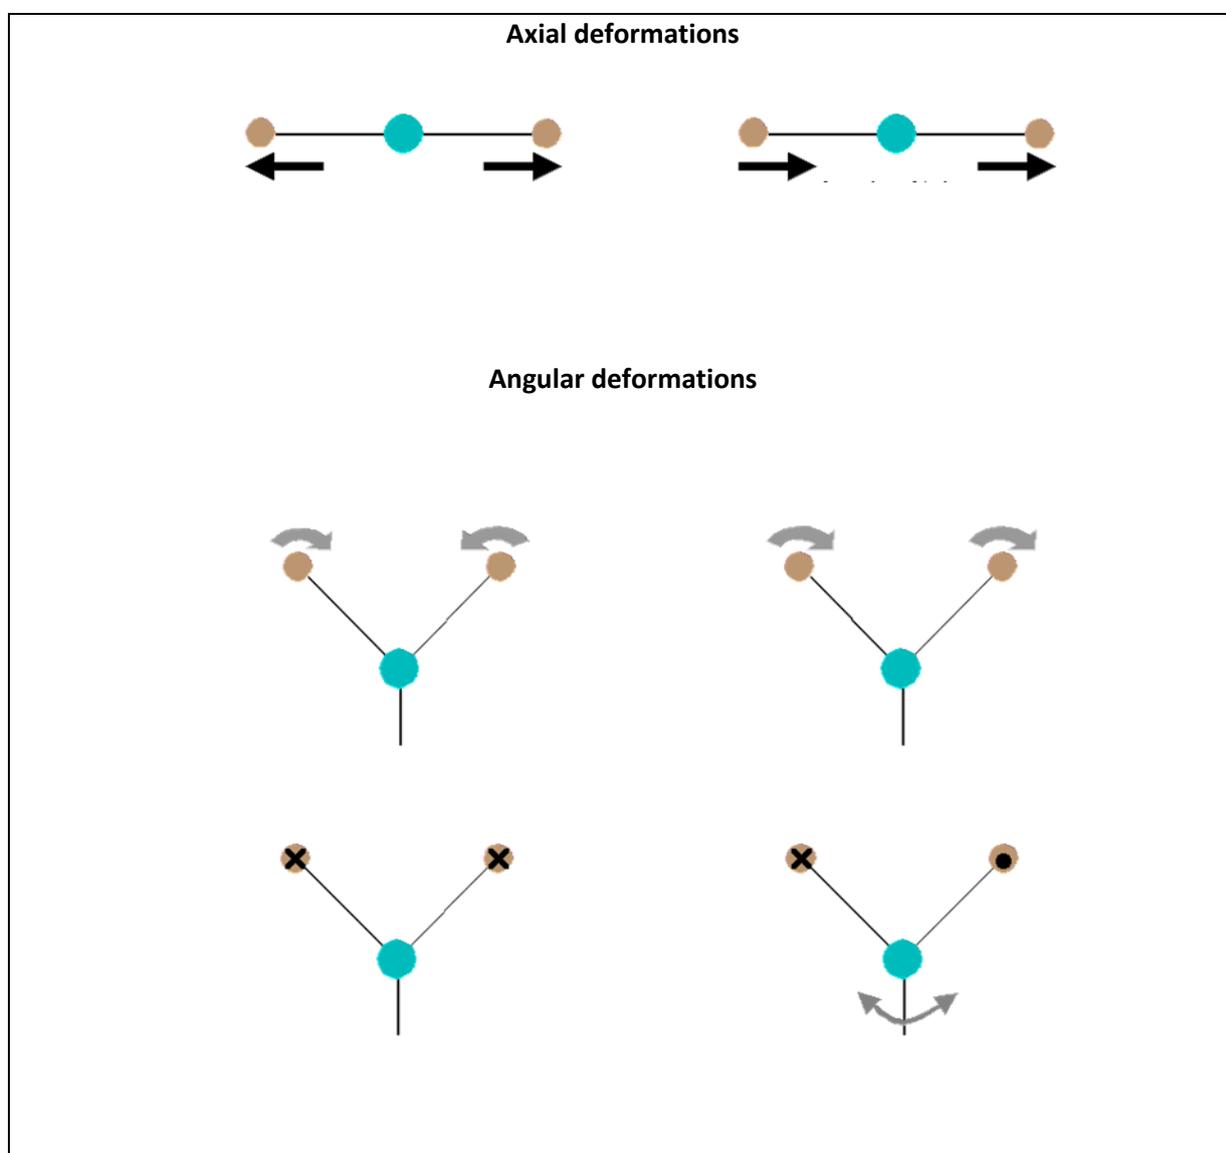
Figure 39 – Axial and angular deformation types (Nakamoto 1970)

The axial deformation types present in the studied crystal-chemical structures are axial and angular type (Figure 39). The axial deformation can be symmetrical or asymmetrical.

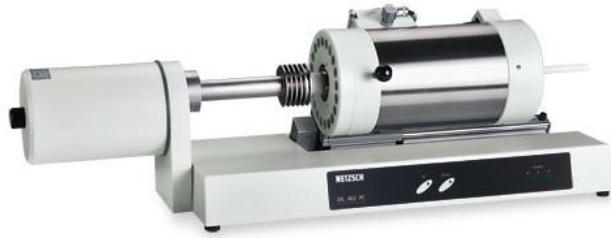
Figure 41 - Netzsch- DIL 402 PC dilatometer (GmbH 2005)

The samples of the ancient ceramic bodies were cut to 25 mm long and 5 mm thick stripes and were submitted to a heating rate of 10°/ min from 30° until 400° C. Calculations were performed by the apparatus software.

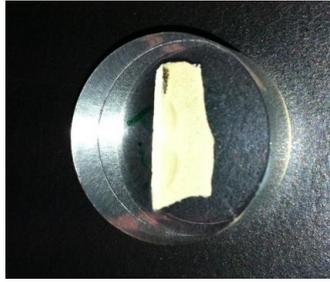
Figure 43 – Resin mounted sample for surface polishing

To enable the visualization of glaze/ceramic body interface, vertical cuts with 1.5 cm length and 0.5 cm height were made in the tile with a sharp mechanical cutting machine, obtaining the simultaneous observation of the glaze, glaze/ceramic body interface and ceramic body. The samples were mounted in resin (Figure 43) and polished with 30, 15, 9, 6, 3 and 1  $\mu\text{m}$  diamond pulp until a smooth surface was obtained. Due to the fact that samples of ceramic body suffer easy degradation in the polishing process, in some samples it was not possible to obtain an even surface.

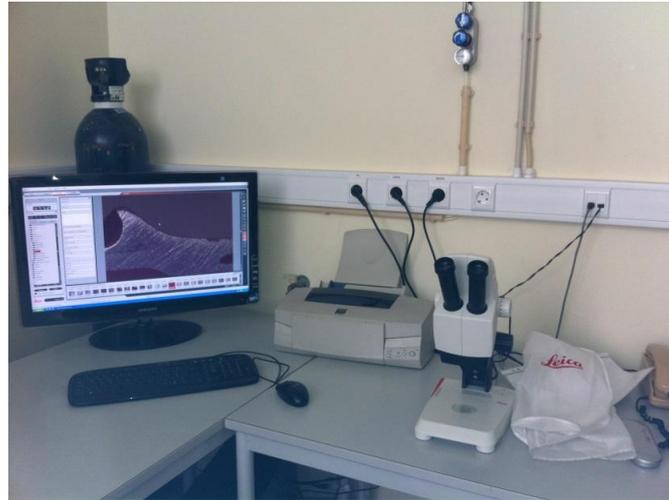
Figure 45 – Optical microscope Leica EZ4HD

of opacification), perpendicular fractures to the glaze surface were made and visualized in an optical microscope Leica EZ4HD (Figure 45). It is a microscope with a magnification range from 8x to 35x with an object field diameter of 5.7 to 25 mm and a working distance of 100 mm. The microscope used allows images visualization and recording in a PC.

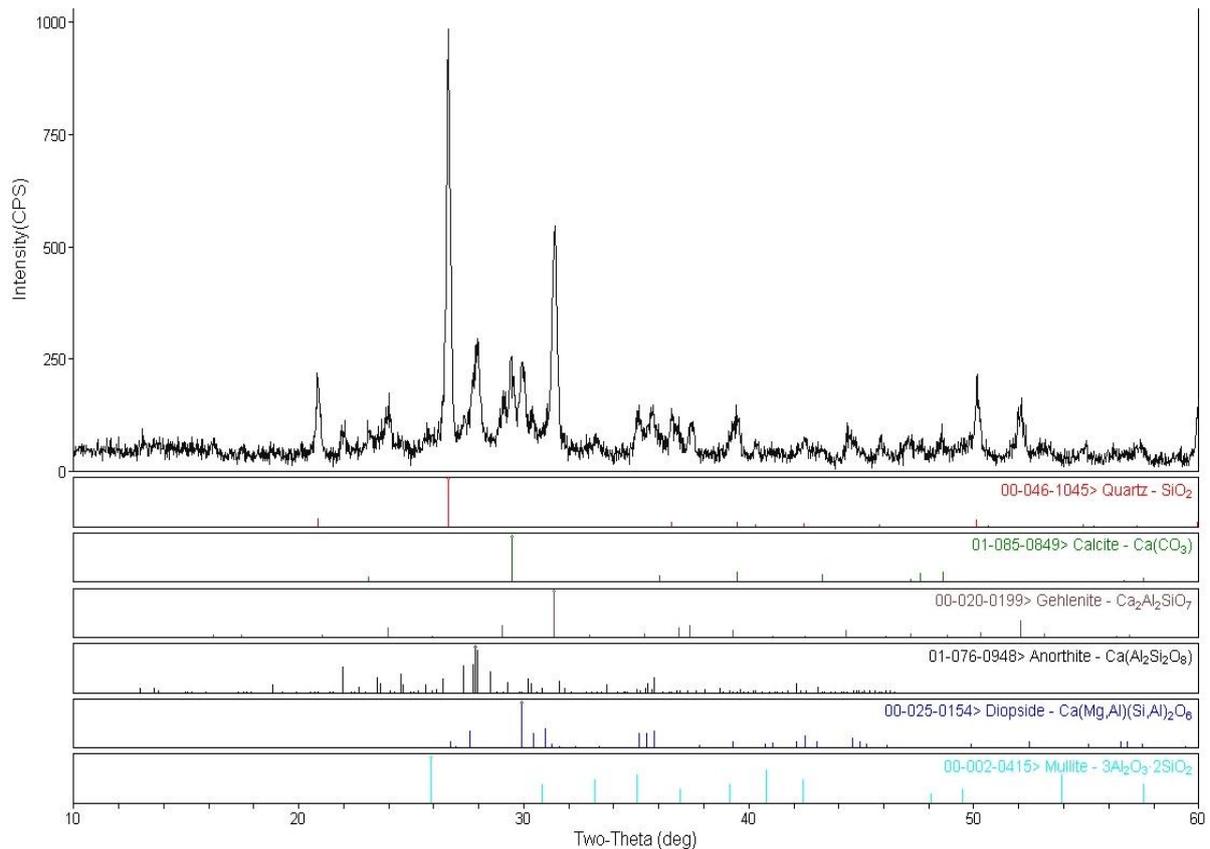
Figure 46 - X-ray diffraction maxima of a calcitic ceramic body

Figure 46 shows the XRD pattern of a calcitic ceramic body presenting the six crystalline phases present in all calcitic ceramic bodies.

Figure 47 portrays a sample XRD pattern with a typical *pó de pedra* ceramic body. Comparing Figure 46 and 47, it can be easily seen that the ceramic bodies crystalline phases are quite different, revealing different raw materials used in the production of each kind of ceramic body. While calcitic ceramic bodies present 4 oxides, *pó de pedra* only exhibit 2.

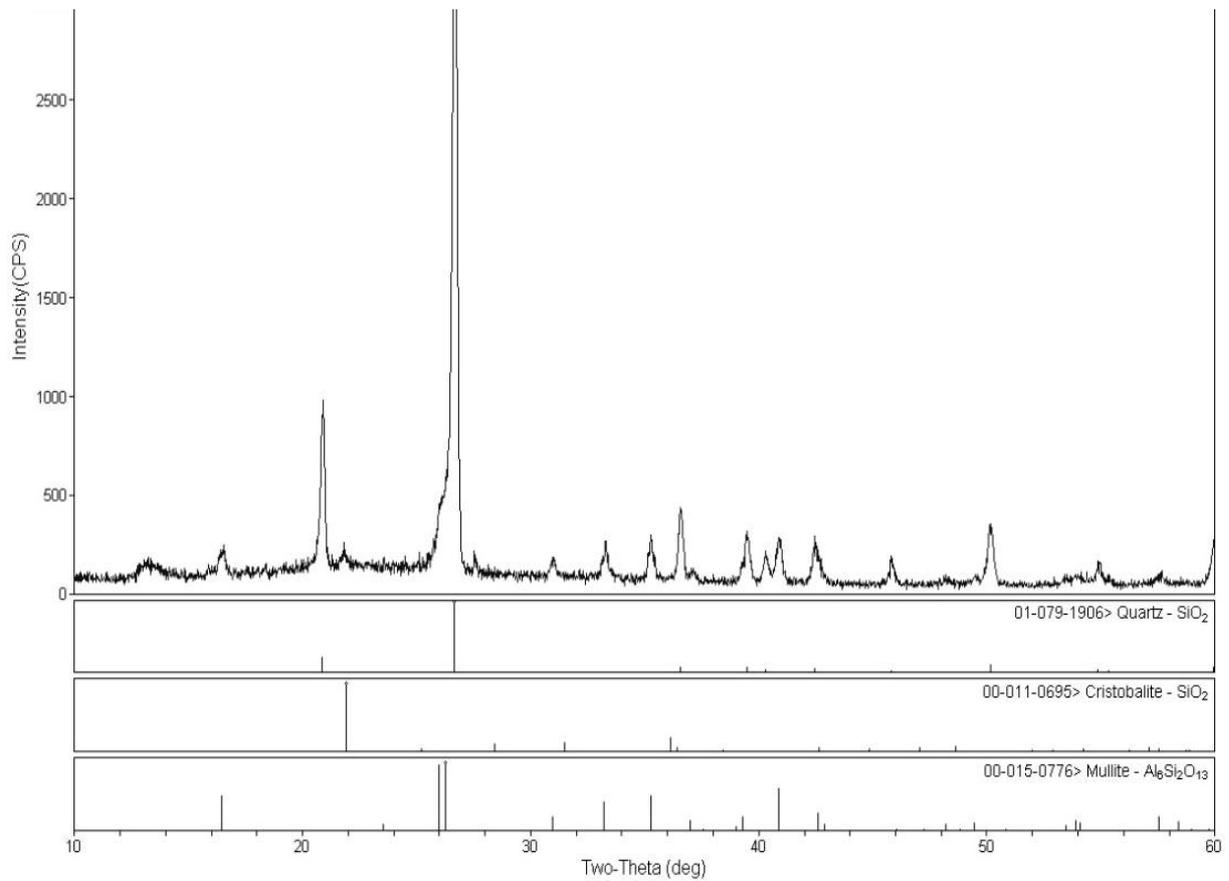
Figure 47 – X-ray diffraction maxima of a *pó de pedra* ceramic body

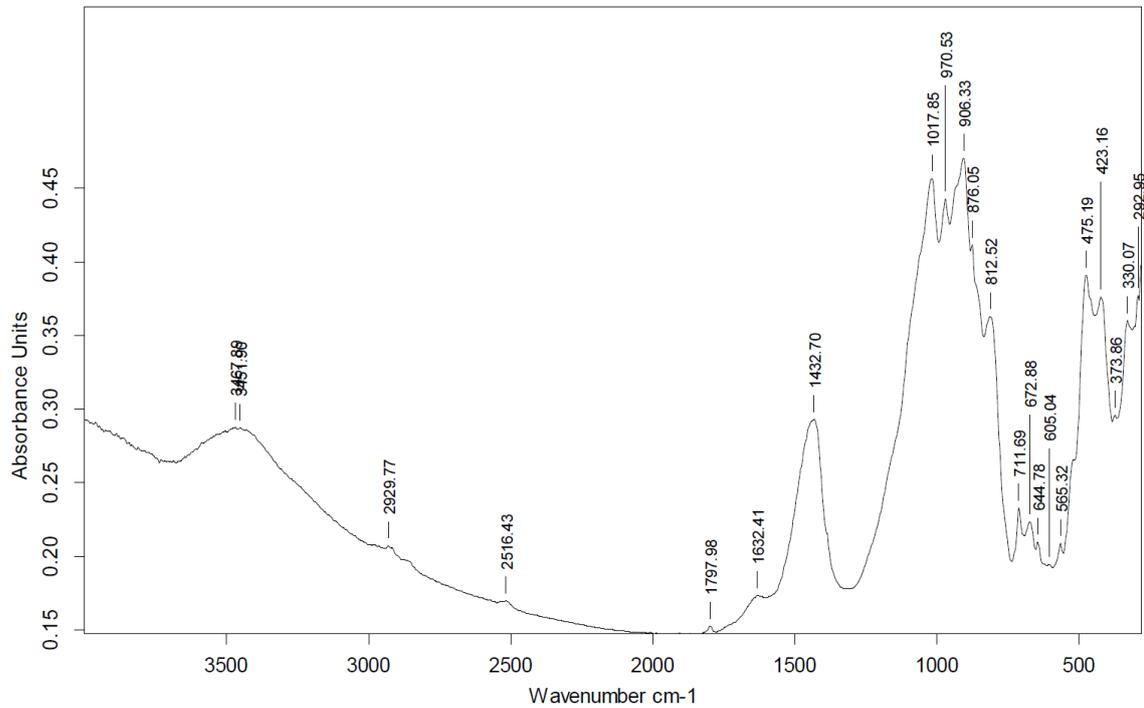
Figure 51 - Sample 24 FTIR spectrum

FTIR was performed in sample P24 which corresponds to a mixture composed of 9 crystalline phases, among which calcite and portlandite can be found. The existence of calcite is present as identified by the vibrations at 1430, 875 and 711  $\text{cm}^{-1}$ . Portlandite (vibration at 474  $\text{cm}^{-1}$ ) is present in a high amount (Figure 51).

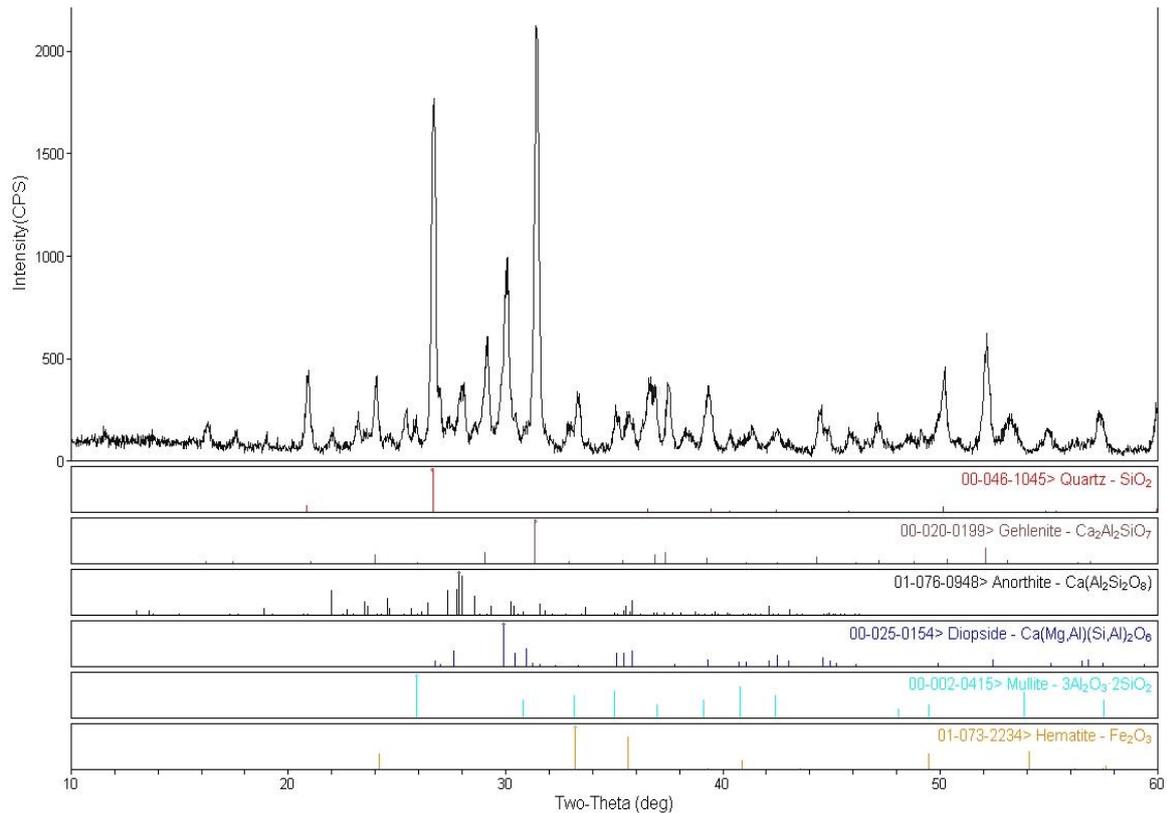
Figure 53 - XRD of P24 after calcination at 1040°C where calcite and portlandite main diffraction maximums are not found

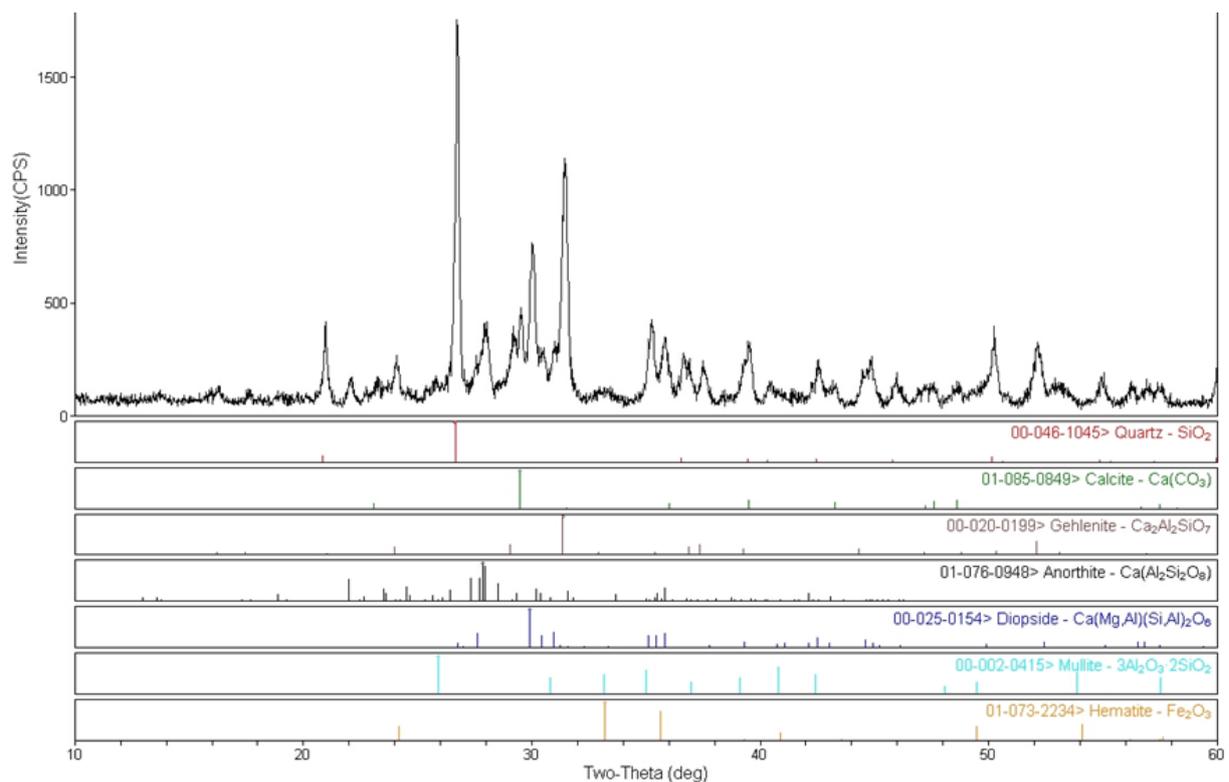
Figure 55 – X-ray diffraction maxima of P104 fired piece

To evaluate the change of crystalline phases with temperature, one sample of P104 calcitic ceramic body, with XRD represented in Figure 55, was calcined at 1150°C (ring temperature). Figure 55 and Figure 56 show the diffraction maxima of the same ceramic body after original firing and after calcination, respectively. It can be seen that the intensity of anorthite diffraction maxima increased considerably as well as that of mullite, while calcite, gehlenite and hematite phases disappeared.

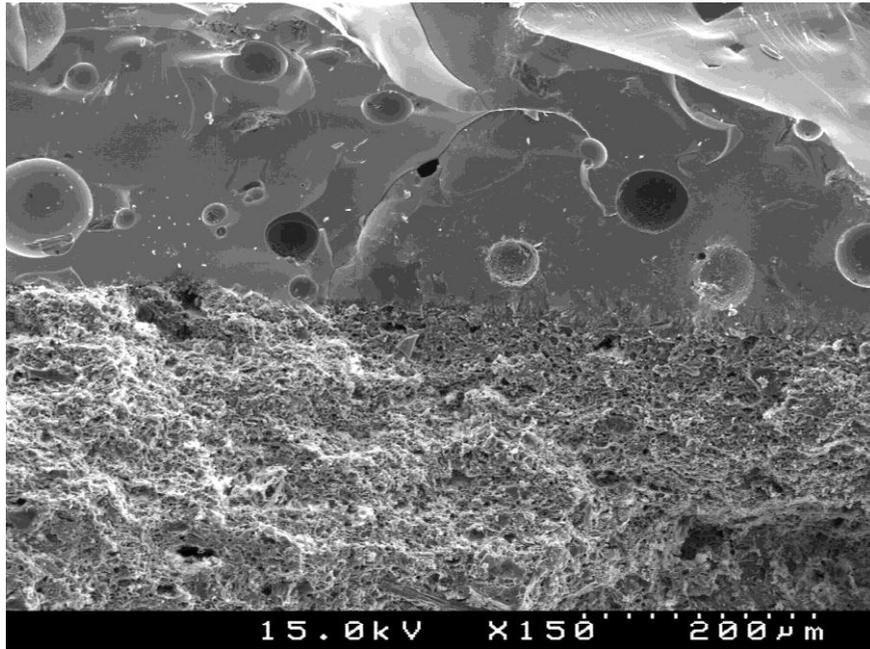
Figure 57 - P10 ceramic body and glaze

Old tiles microstructure shows a system with a large quantity of pores of different sizes, vacant spaces, salt crystals, and large particles of ungrounded raw materials as well as of other materials' particles. In Figure 57 and 58 it can be seen P10 and P89 ceramic bodies and glazes.

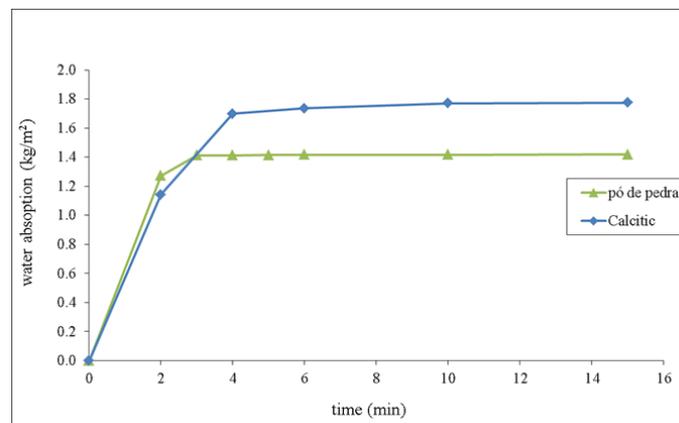
Figure 63 – An example of *pó de pedra* and calcitic ceramic bodies' water absorption due to capilar action curves

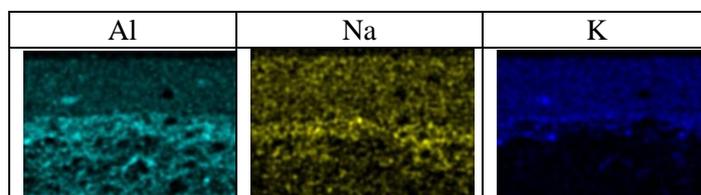
Table 21 – Elementary EDS photos of P133 (Al, Na, K)

Table 22 shows the average of 5 different measurements made in the interface of each samples. It can be seen that samples present interfaces width variations, from an unmeasurable interface until an interface of about 54  $\mu\text{m}$ . When cutting P24, which has an interface that is not measurable, it became clear that glaze peeled off on the saw cutting path, revealing a deficient glaze/ceramic body interaction.

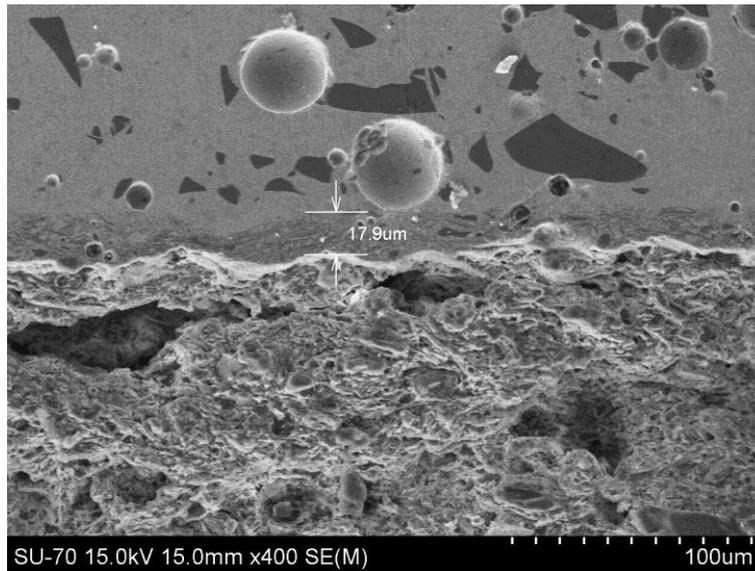
Figure 64 – SEM image of interface glaze/ceramic body of a contemporary tile (HC)

In order to have a comparison term concerning glaze/ceramic body interface, this feature was analysed in a contemporary tile used in restoration as a pictorial replica. As can be seen in Figure 64, the interface has a mean value of about 18  $\mu\text{m}$ . In Figure 65 an interface closer look can be seen, showing its uneven profile as well as the glassy aspect. As modern tile production is more controlled and stable than 100 years ago, it is considered that the interface value found in this contemporary tile is representative within its brand.

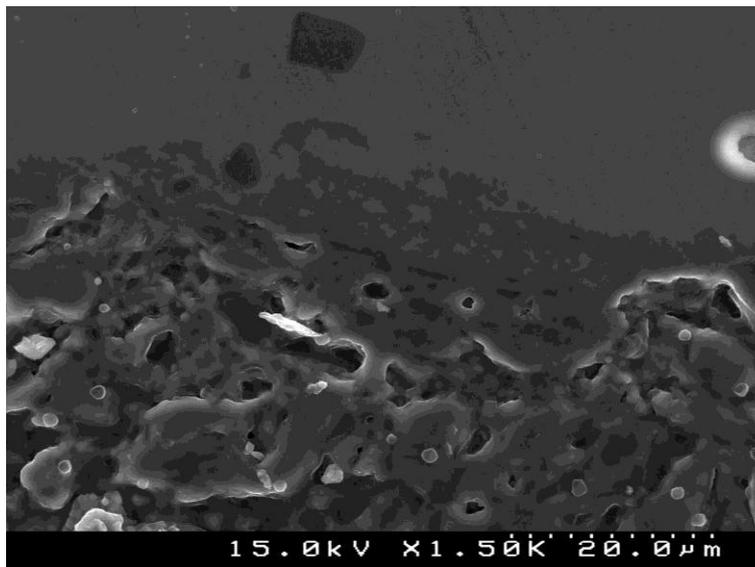
Figure 65 – HC interface glaze/ceramic body closer look

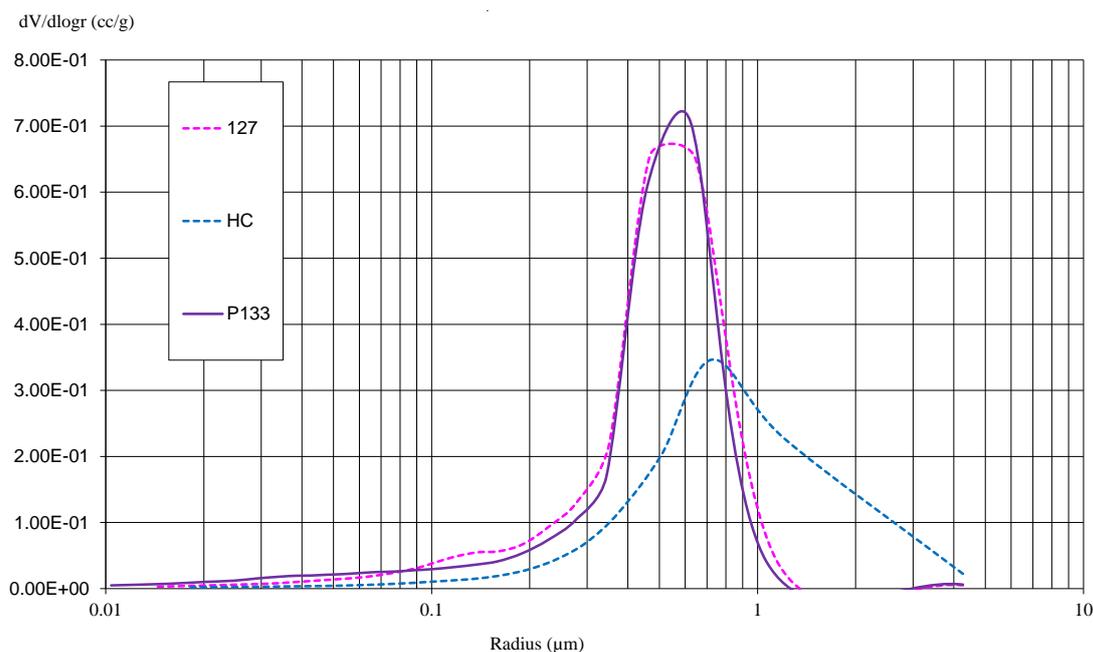
Figure 66 – Volume of mercury intrusion data in 3 samples (P127, HC and P133)

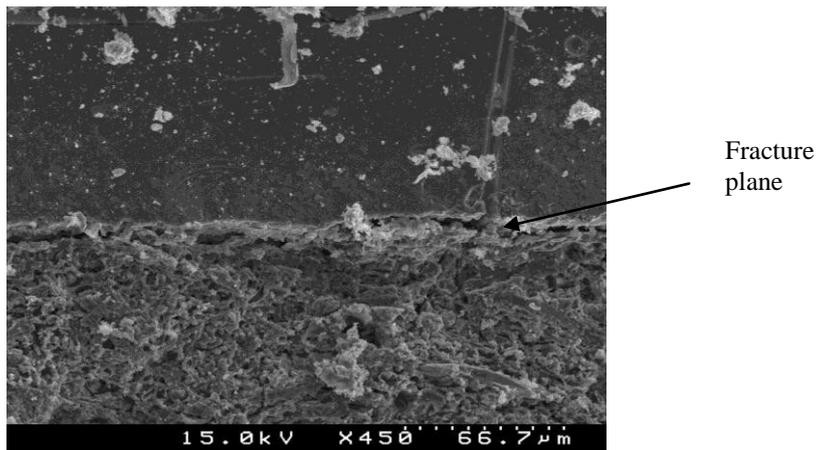
Figure 67 – A SEM cut view where can be seen a fracture beneath the glaze of P133

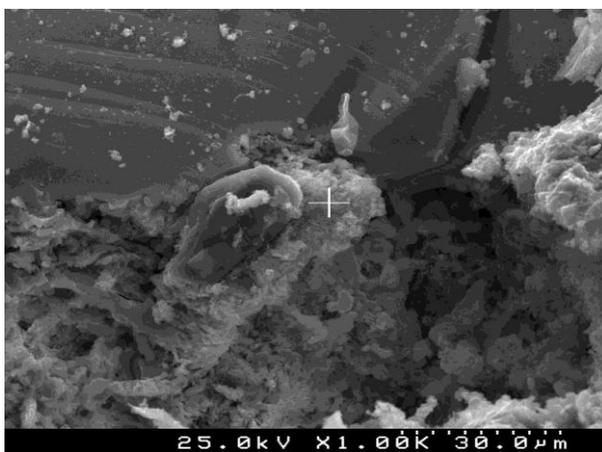
Figure 68 – Salts beneath the glaze of P133

Analysing closely Figure 68, crystals (marked with a cross) can be seen occupying porosity underneath the glaze/ceramic body interface. In Figure 69, the crystals EDS can be seen. Analysing the EDS it cannot be forgotten that the signal from what is underneath the crystals is also captured by the EDS sensor.

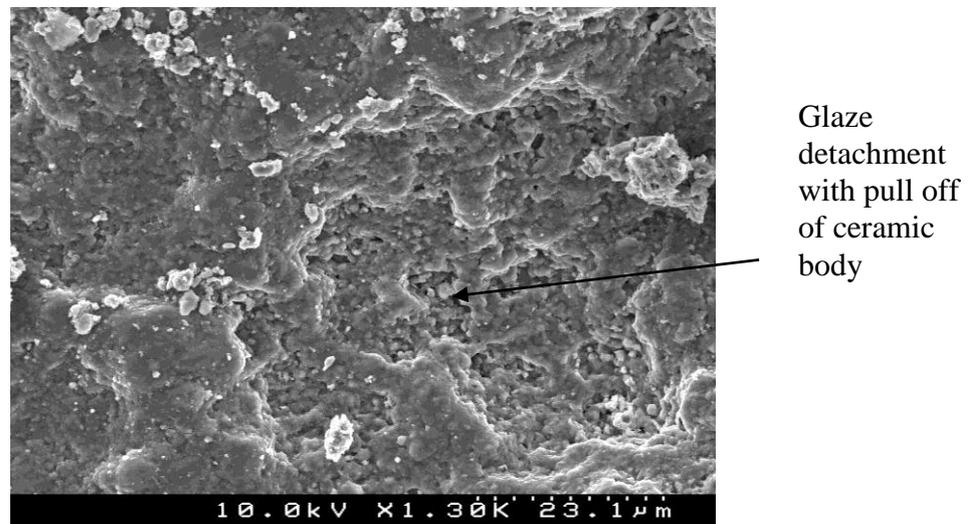
Figure 70 – A SEM view of the surface that suffered from glaze detachment

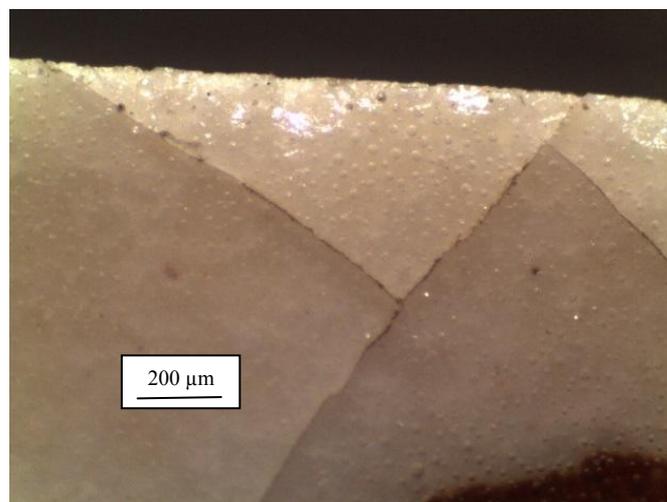
Figure 71 – Example of crazing suffered by all *pó de pedra* tiles' glazes

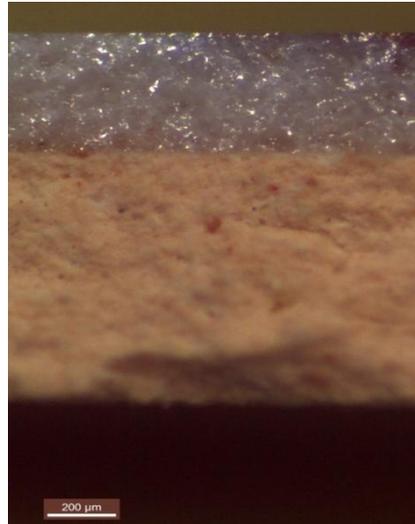
Figure 72 – Example of an opaque glaze in a perpendicular view

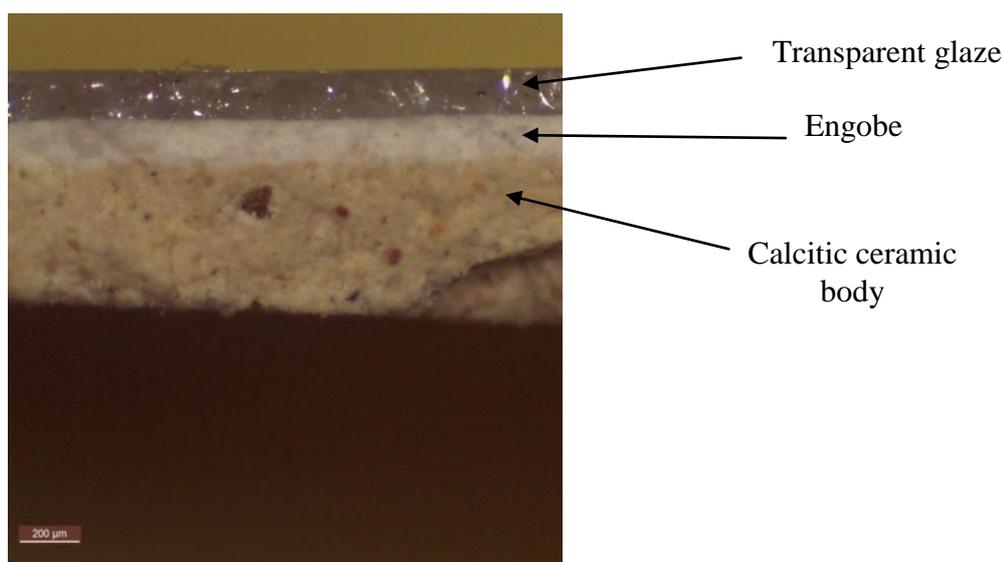
Figure 73 – Example of a calcitic tile with double glaze layer

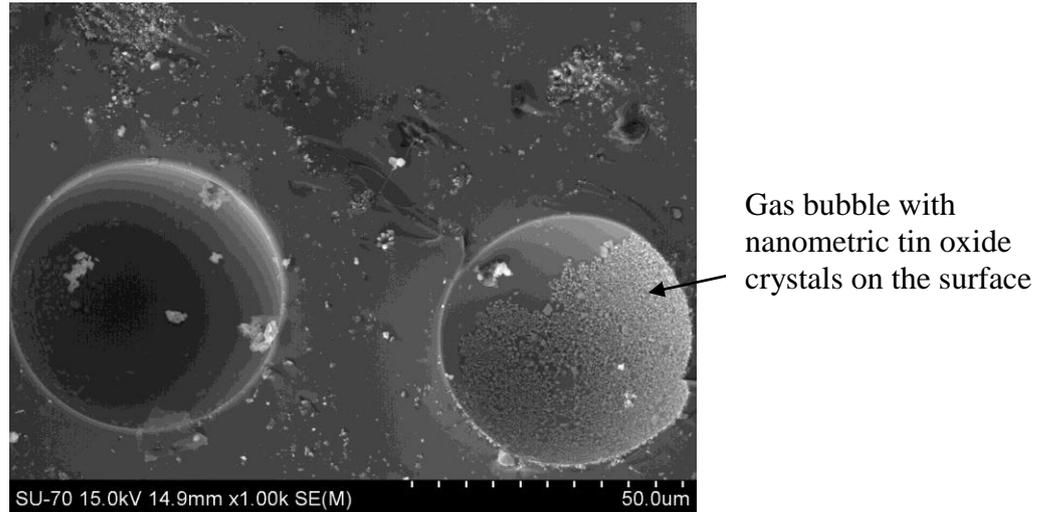
Figure 75 – Tin oxide cristalization in an opaque glaze (P24)

Cassiterite crystals were observed and identified by EDS. These nanocrystals are disseminated in a non-homogeneous way in the entire glaze matrix (Figure 75).

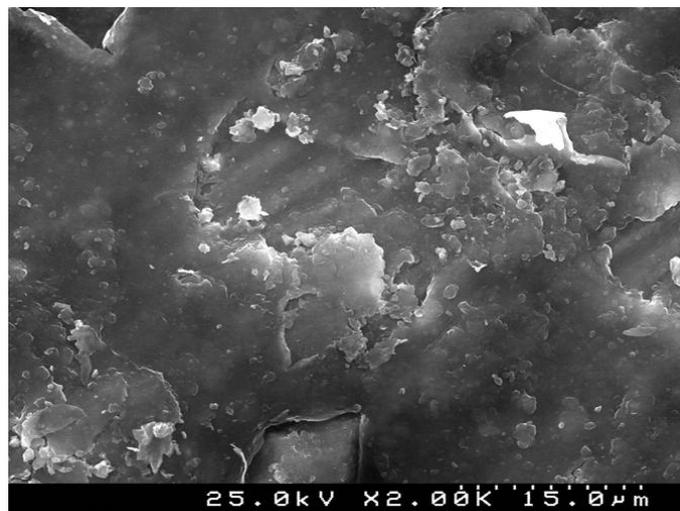
Figure 76 - P10 SEM glaze surface observation where chemical attack can be seen

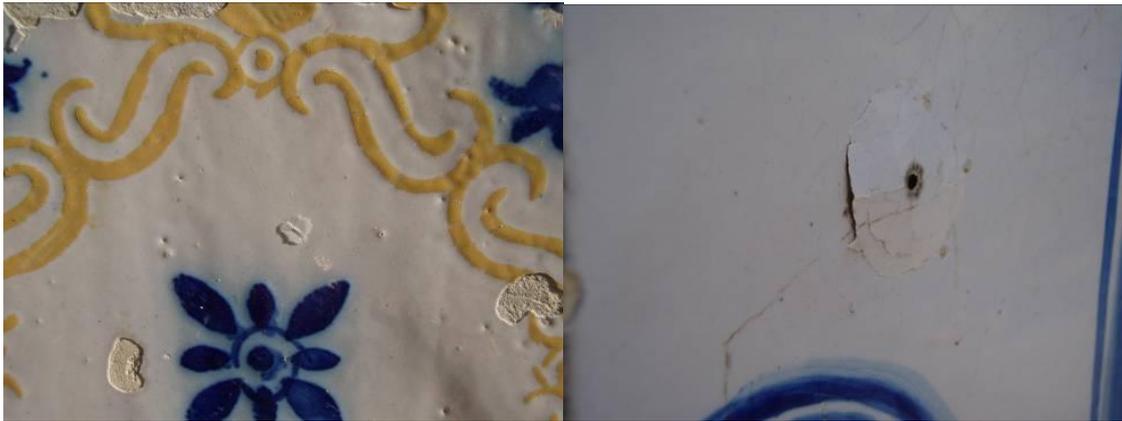
Figure 78 – Tiles with pores and associated pathology (author' photos)

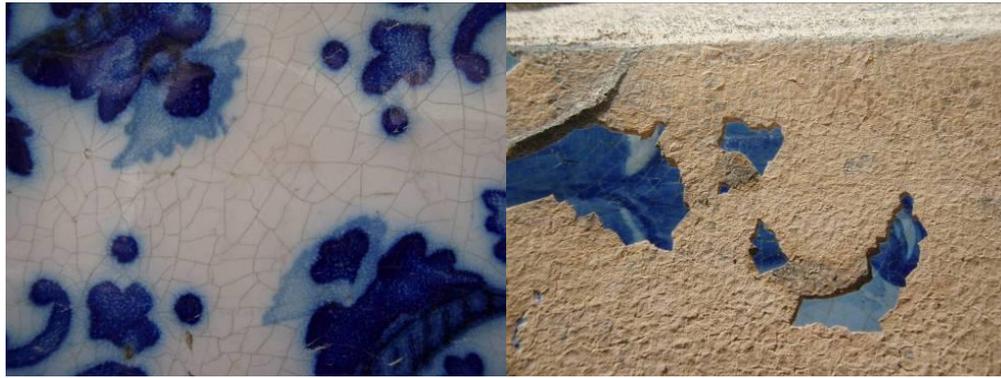
Figure 79 – Example of glaze crazing (on the left side) and glaze detachment by glaze crazing (on the right)

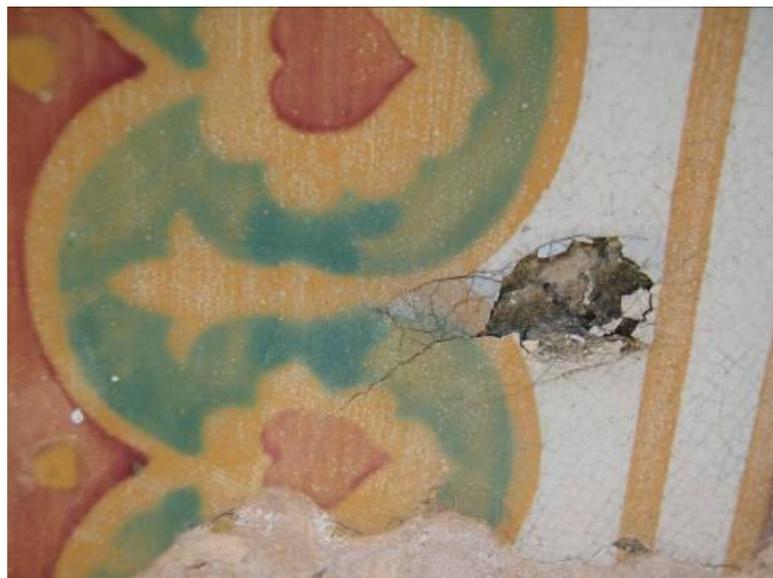
Figure 80 – Example of glaze crazing provoked by persistent humidity (author's photos)

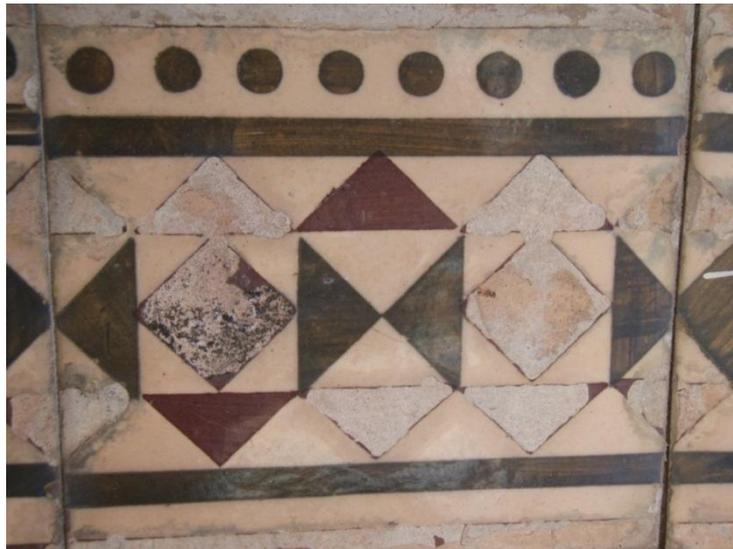
Figure 81 - Colour detachment due to a poor colour/glaze thermal expansion coefficient adjustment (author' photos)

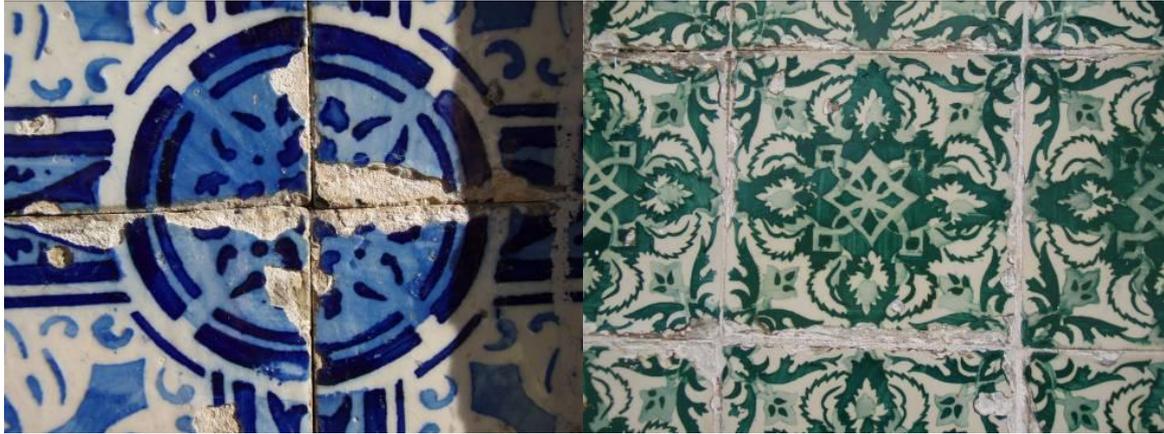
Figure 82– Examples of tile perimeter glaze detachment (author’ photos)

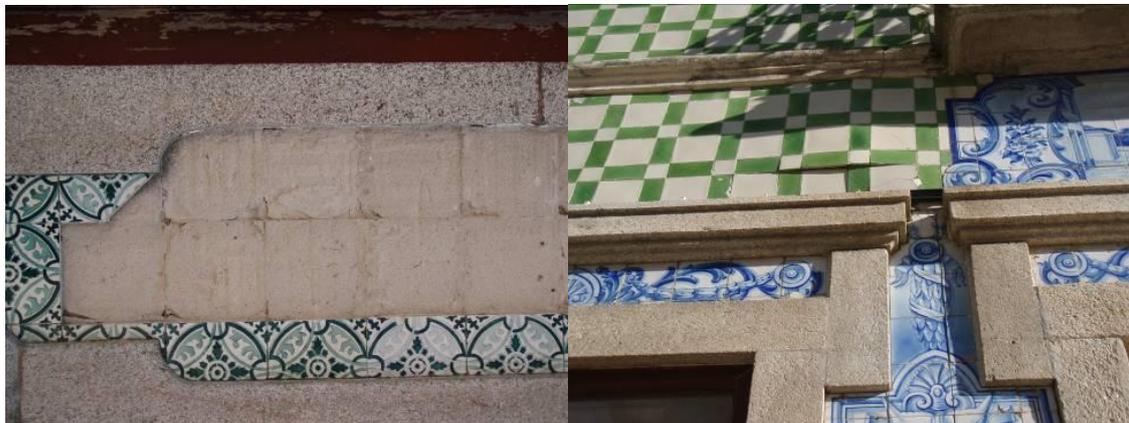
Figure 83 – Examples of lack of mortar/tile adherence (author’ photos)

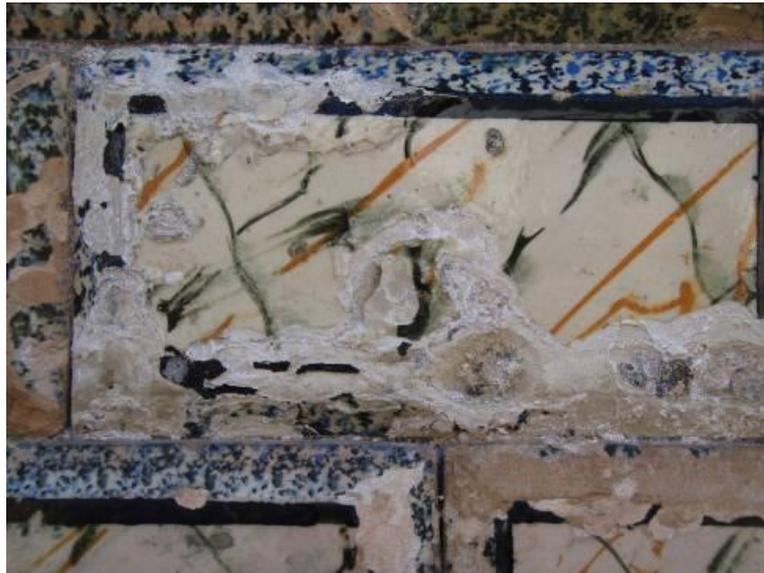
Figure 84 – Example of glaze detachment caused by salt crystallization (author's photos)
