**Estudo de azulejos do século XIX e  
desenvolvimento de réplicas**

**Study of 19<sup>th</sup> century wall tiles for technical replicas  
development**

Tese apresentada à Universidade de Aveiro para cumprimento dos requisitos necessários à obtenção de grau de Doutor em Engenharia Civil, realizada sob a orientação científica da Doutora Ana Luísa Lomelino Velosa, Professora Auxiliar do Departamento de Engenharia Civil da Universidade de Aveiro e coorientação do Doutor Paulo Barreto Cachim, Professor Associado do Departamento de Engenharia Civil da Universidade de Aveiro e do Doutor João Paulo Coroado, Professor Coordenador do Instituto Politécnico de Tomar.

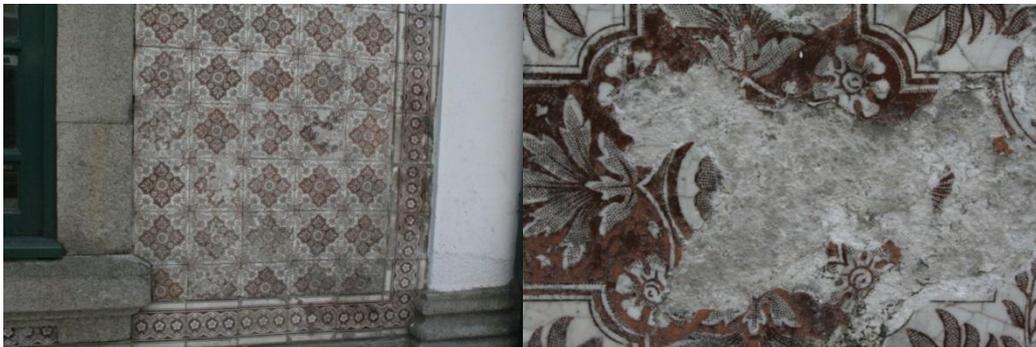
Figure 85 – Example façade and tile suffering from glaze detachment

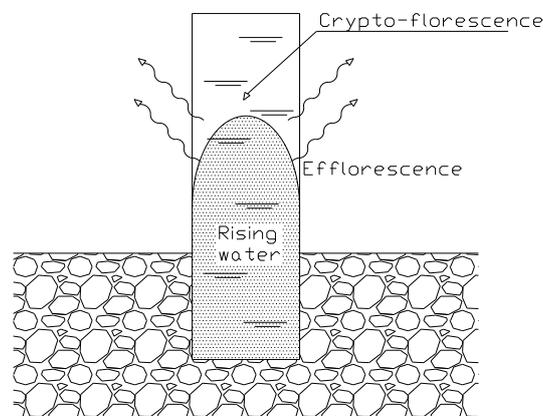
Figure 86 – Efflorescence and crypto-florescence example (Scherer 1999)

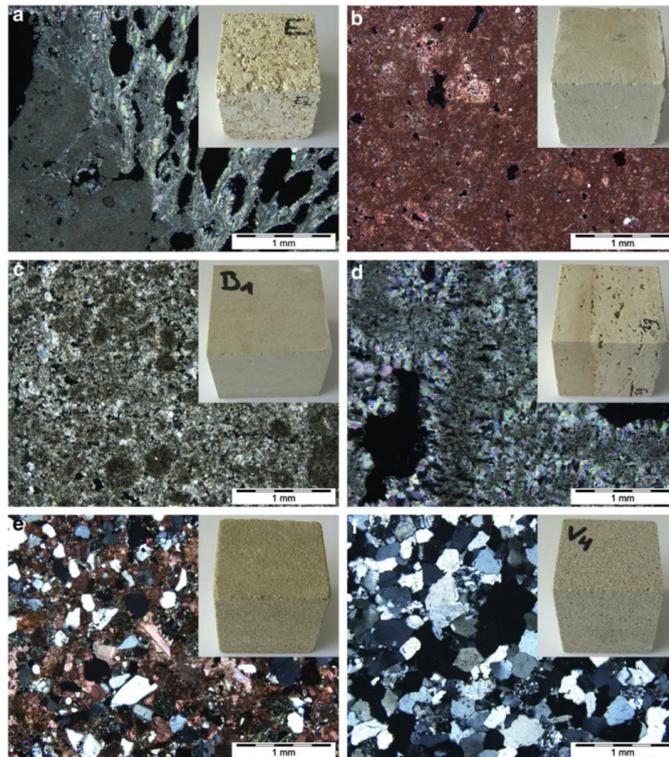
Figure 87 – Polarized optical microscope microphotographs of: a) Santa Pudia limestone (SP), b) Fraga limestone (CF), c) Bonar dolostone (DB), d) travertine from Albox (TA), e) Uncastillo sanstone (AU), f) Villaviciosa sanstone (AV) (E.Molina, G.Cultrone et al. 2011).

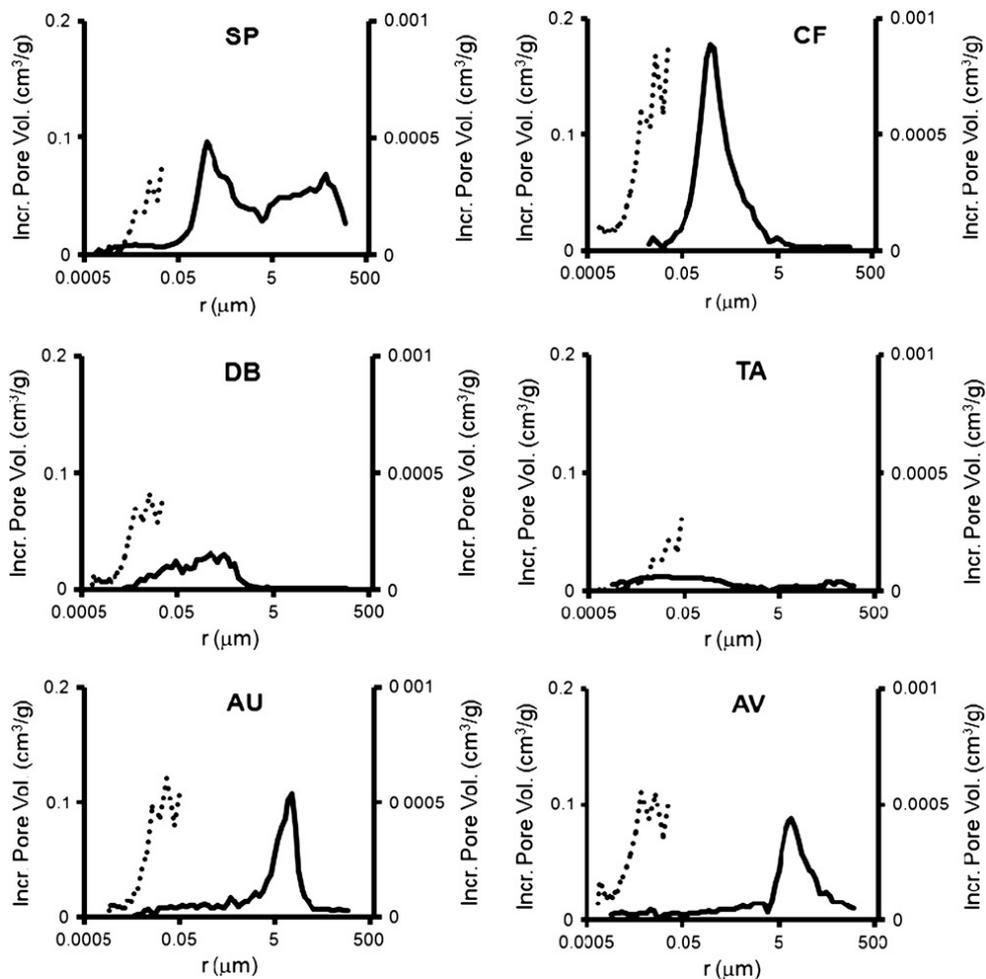
Figure 88 - Mercury intrusion porosimetry data (continuous line) of studied samples by Molina (E.Molina, G.Cultrone et al. 2011)

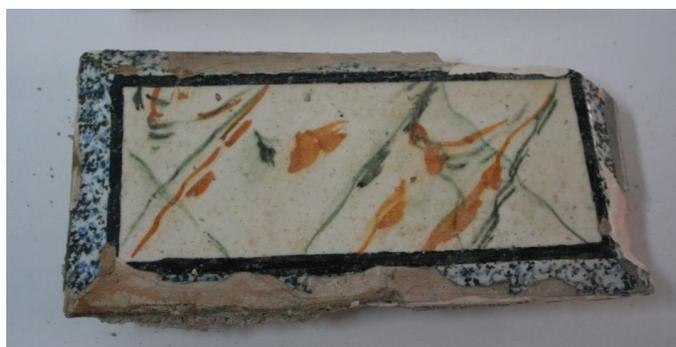
Figure 90 - Glaze detachment in the tile borders caused by salt crystallization.

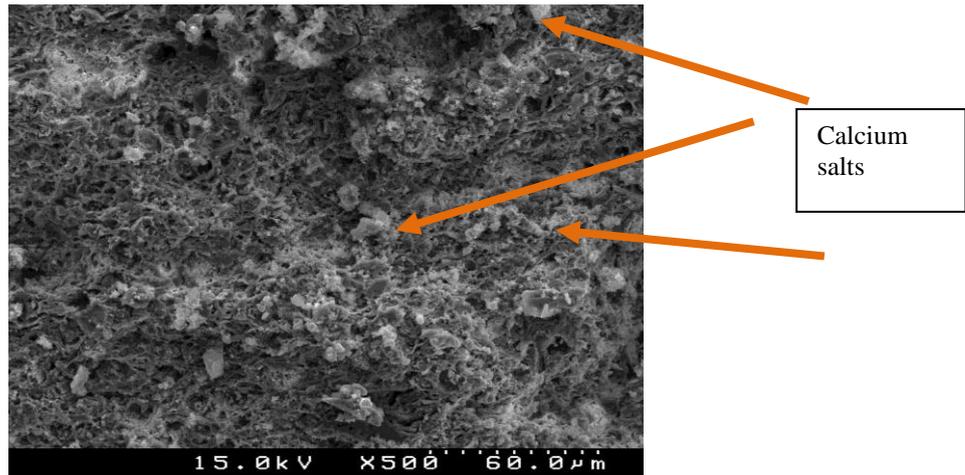
Figure 92 – P89 ceramic body with numerous calcium crystallizations

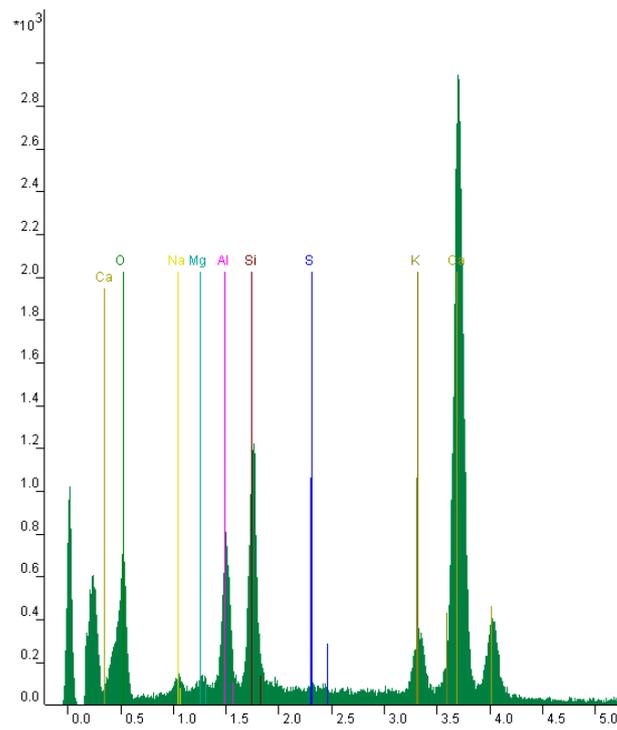
Figure 93 – EDS of the crystals

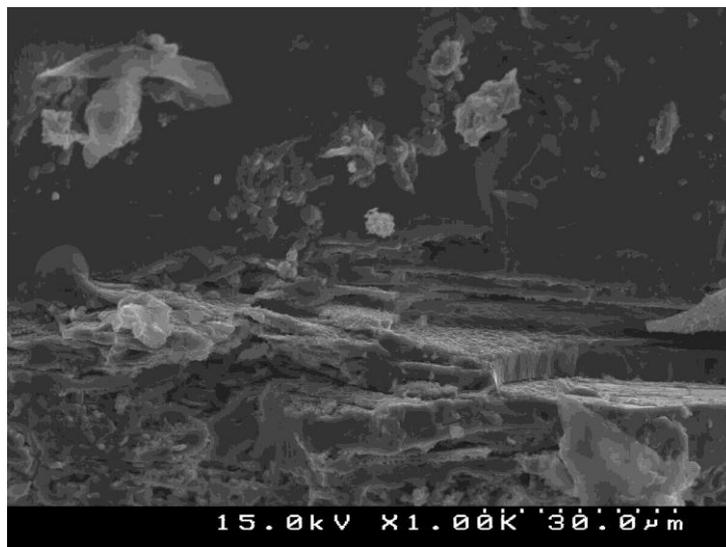
Figure 94 – Crystallized salts in the ceramic body/glaze interface, provoking structural rupture

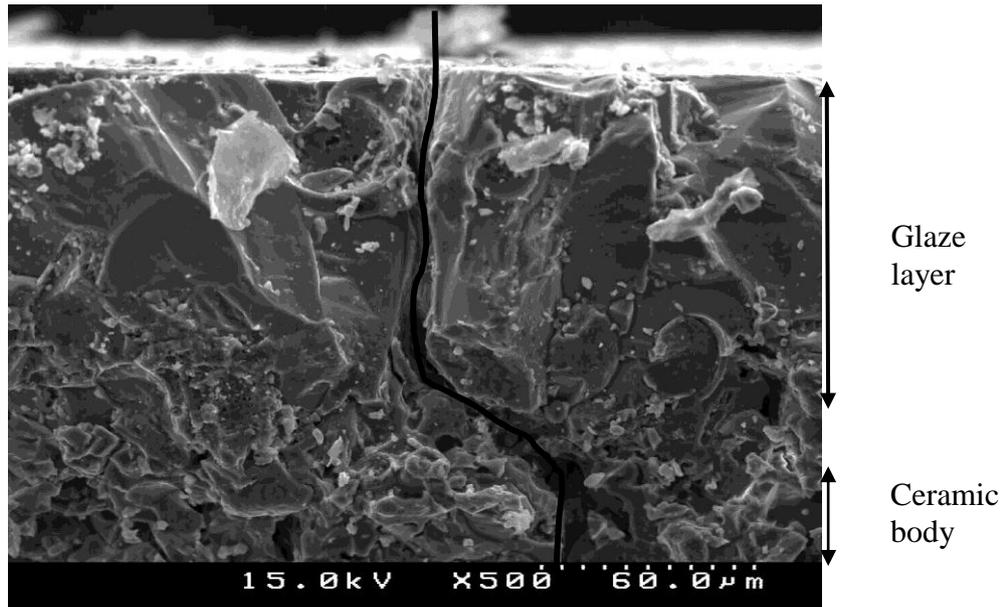
Figure 95 – Path of destruction made by salt ascension

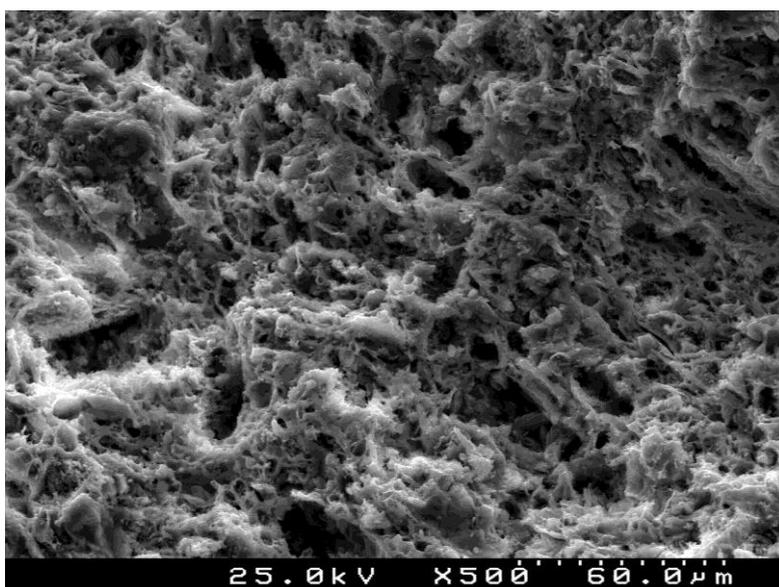
Figure 96 – Microstructure of a tile never used

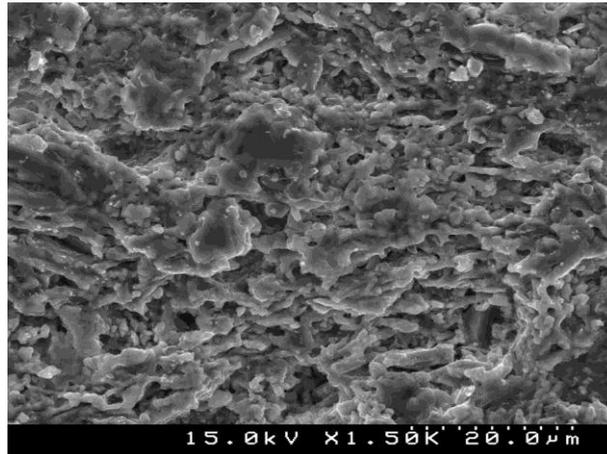
Figure 98 – Sample 1 microstructure

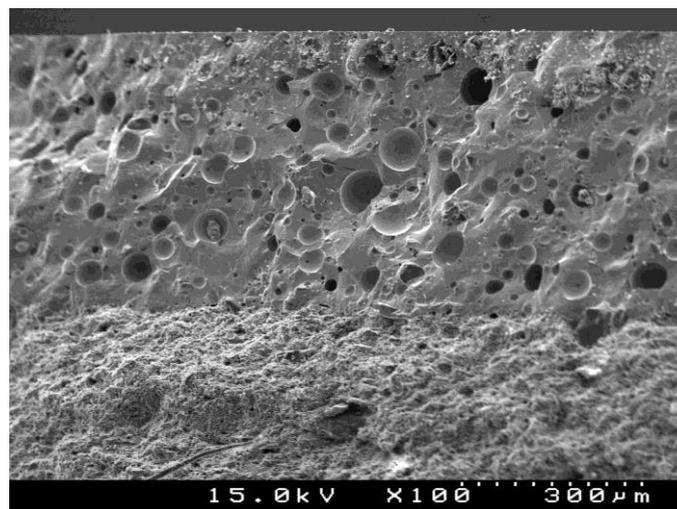
Figure 99 – Sample 1 glaze and ceramic body SEM observation. Sample in fracture

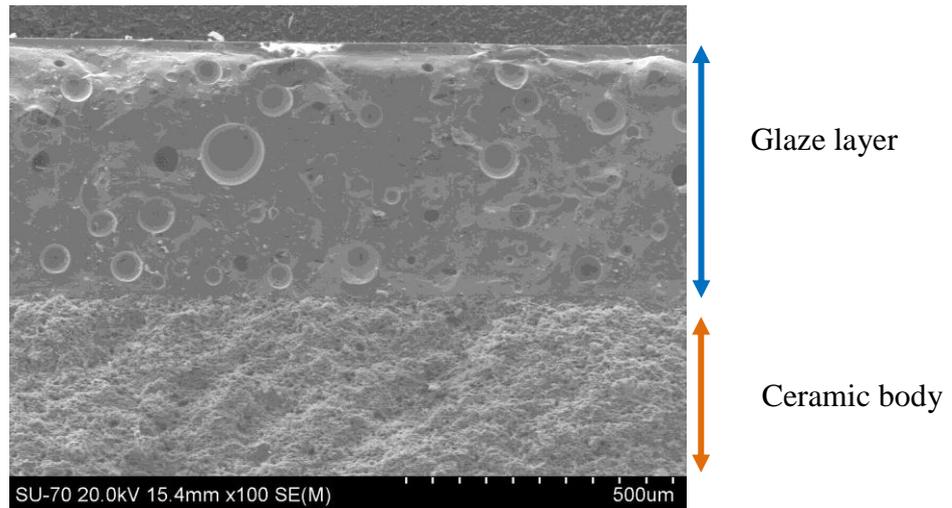
Figure 100 – Old tile glaze and ceramic body SEM observation. Sample in fracture

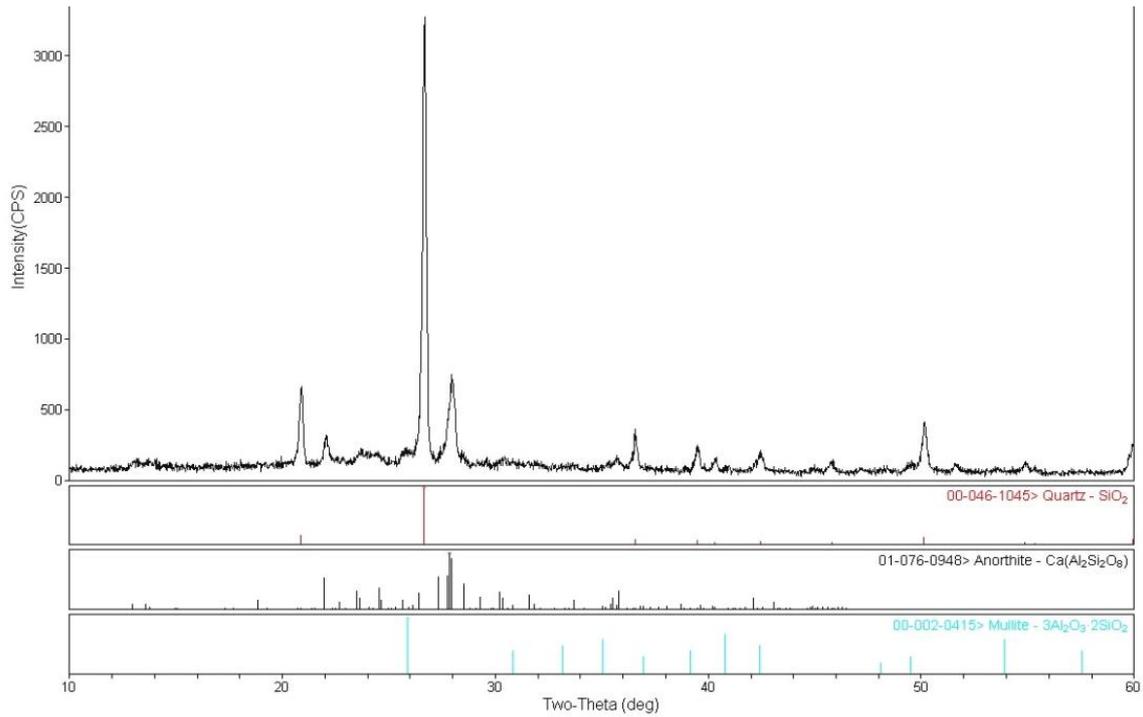
Figure 101 – Sample 2, XRD

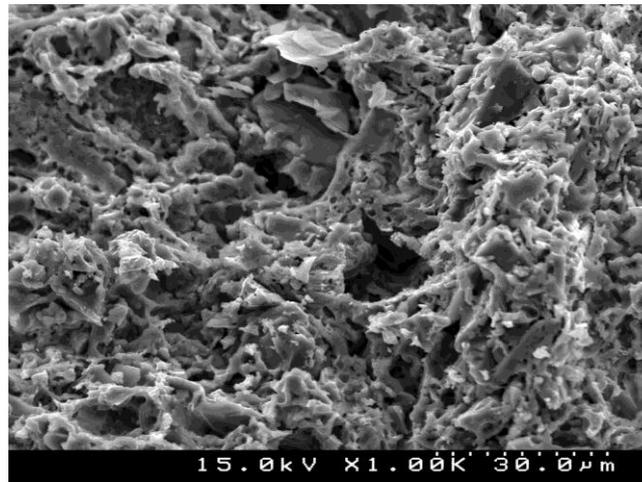
Figure 102 – Samples 2 microstructure

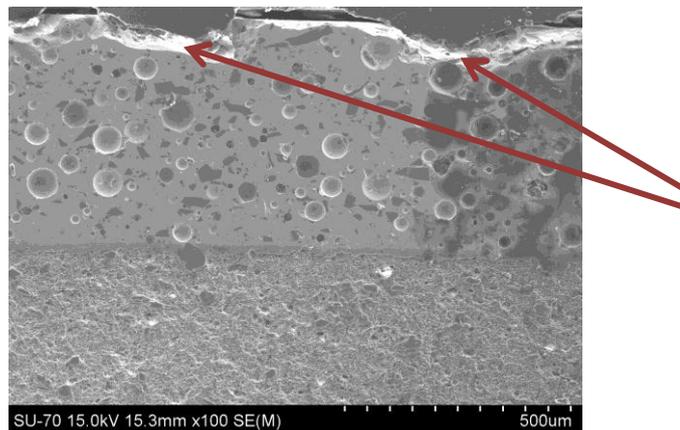
Figure 104 – Sample 2 glaze fracture due to cutting

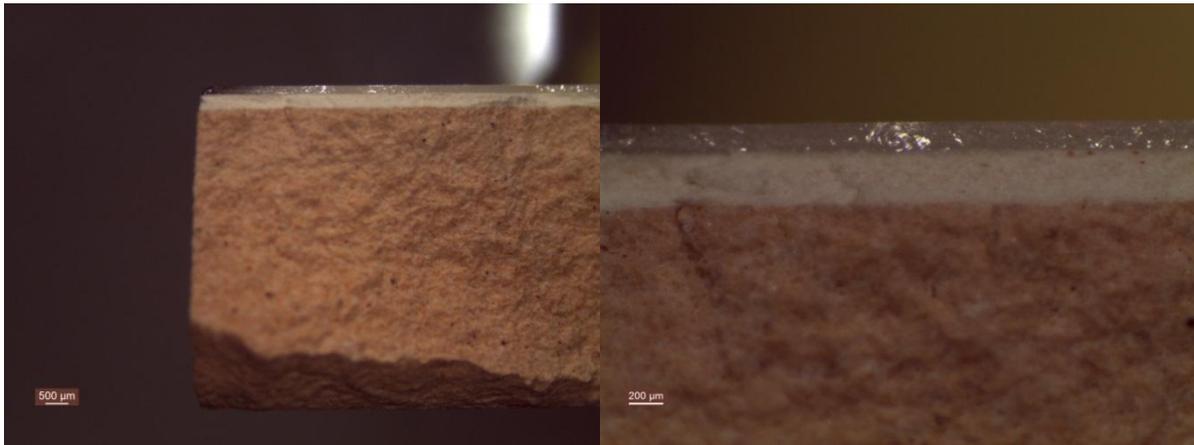
Figure 105 – Engobe and glaze thickness seen by optical microscope
